**Flood Control Project Maintenance  
Levee Inspections**

**Fall 2012 Levee Maintenance Deficiency Summary Report**

**Reclamation District No. 2085 Kasson**

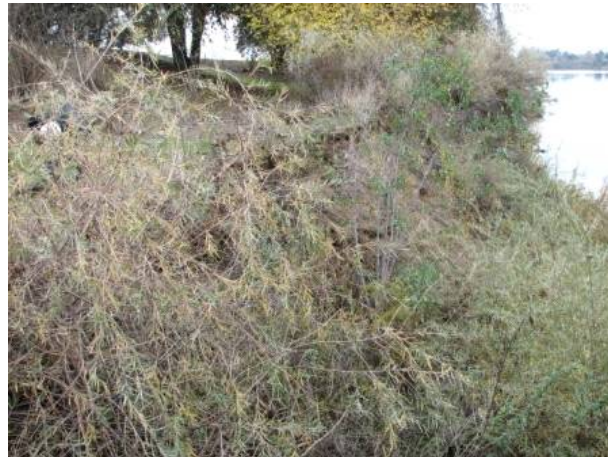
SJR2012\_RD2085U01RM66.5\_1.jpg

Looking downstream

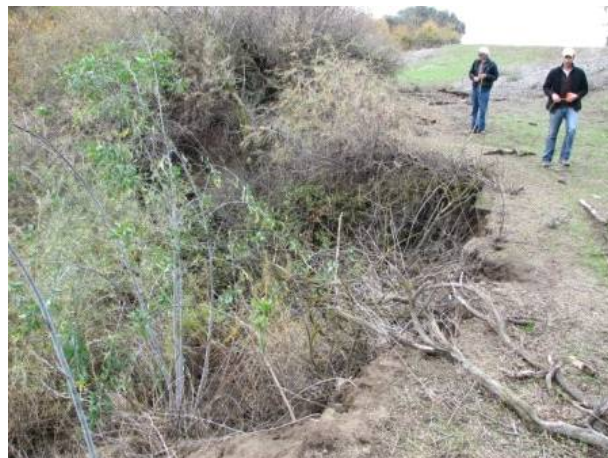
SJR2012\_RD2085U01RM66.5\_2.jpg

Levee Mile Report Line	15
Start Levee Mile	2.24
End Levee Mile	2.26
Location	Water Side
Category	Supplemental
Item	DWR Erosion Survey

Looking upstream
